Characterization of 3M Purification Betapure™ NT-T Series Filter Cartridges Employed as D.E. Trap Filters in a Major U.S. Brewery

Thomas O'Brien, Ph.D. Senior Applications Specialist, Scientific Applications Support Services Healthcare, Food & Beverage

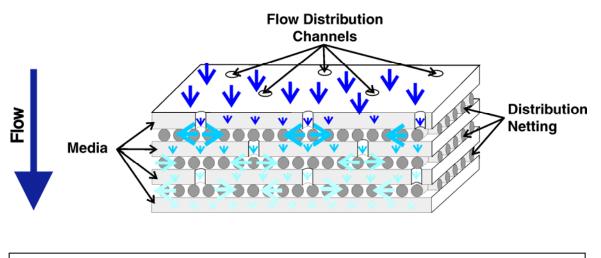
Figure 1. Betapure NT-T Series filter media design

3M Purification Betapure NT-T Series filters were designed to provide consistent, absolute rated filtration, as well as the high D.E. fine holding capacity needed in the brewery. Betapure NT-T Series filter construction combines a unique polypropylene filter media with fluid distribution netting to form multiple layers. Critically positioned media flow channels allow greater movement of fluid from layer to layer (Figure 1).

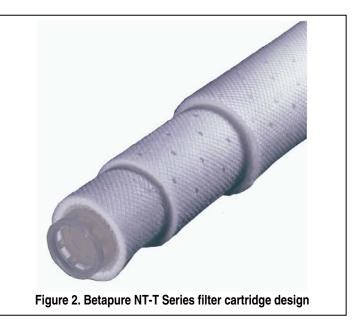
Three distinct media sections, made from multiple media/netting layers, are combined to form a filter cartridge (Figure 2). The outer and middle sections contain multiple layers of interleaved filter media and fluid distribution netting. Within each media layer, a portion of the fluid travels through the media while the balance of fluid is delivered directly to the next distribution layer through the flow channels. The fluid distribution netting provides longitudinal and latitudinal flow paths to evenly distribute fluid flow across the surface of each successive filter media layer.

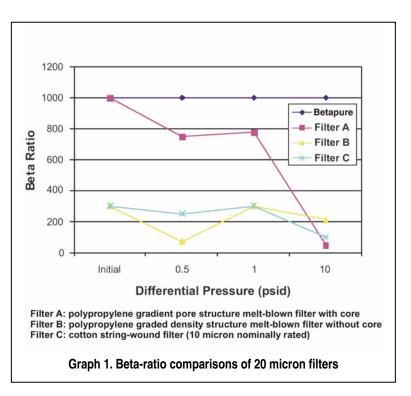
As *Graph 1* shows, **Betapure NT-T** Series filters maintain their absolute rating throughout the entire life of the filter, retaining particles even as the differential pressure builds. Filters A, B, and C show degradation in the Beta Ratio as the differential pressure increases. These filters exhibit a pattern of unloading previously retained particles, or a loss of filtration efficiency.

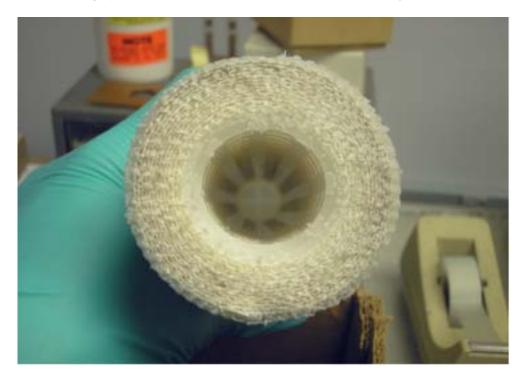
Figure 3. Photographs of Cross sections and Contaminated Media Layers

The resulting cross section indicated that the contaminants plugging the cartridge had penetrated approximately 2/3 of the depth of the filter cartridge (as shown in the photograph presented in Figure 3A). A beige powdery substance was clearly evident on the outermost media layers, its intensity gradually diminishing toward the downstream center of the cartridge, until it was no longer visible by approximately the 10^{th} media layer (as presented in the photographs in Figures 3B, 3C and 3D).

3A. Cross section of Returned Betapure NT-T Series Cartridge – note penetration of D.E. fines into the media pack of the filter.

The contaminants found penetrate approximately 2/3 of the way through the media layers of the returned Betapure NT-T Series cartridge. This indicates that the grade of Betapure NT-T Series filter selected was open enough to allow penetration of the contaminants into a significant depth of the filter media for maximum utilization of the effective media depth. Maximum utilization of the media ensures longer filter life.

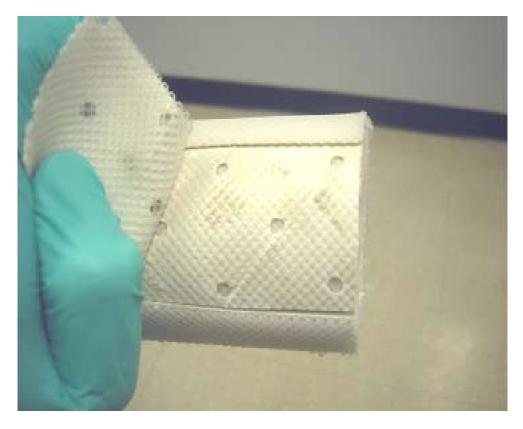
3B. Photograph of Media Layer #2 showing contamination

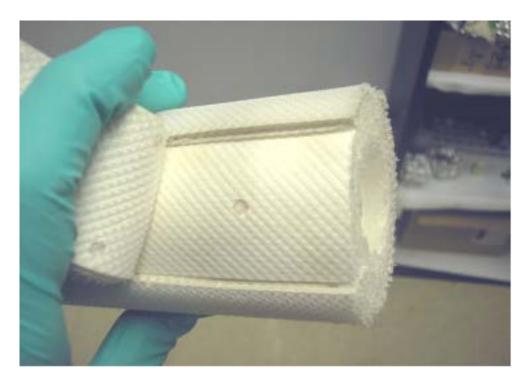
3C. Photograph of Media Layer #5 showing lesser contamination

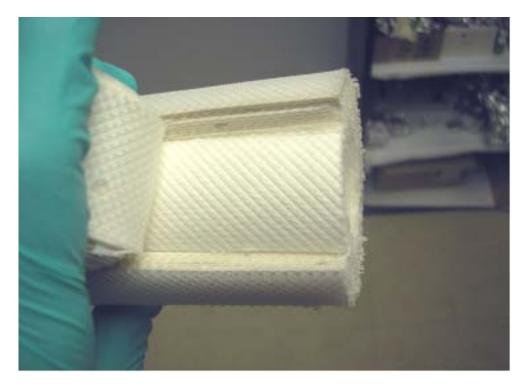
3D. Photograph of Media Layer #10 showing the absence of visual contamination

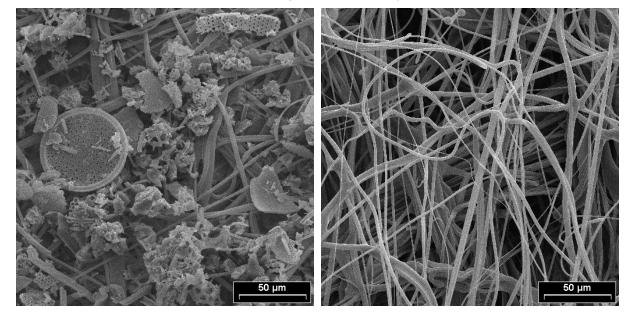
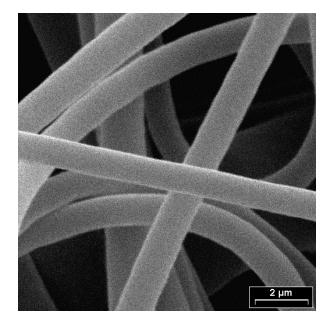
Figure 4.

SEM examination revealed the majority of the contaminant particulates found on all three media layers were D.E. (diatomaceous earth) as shown in the SEM photomicrographs presented in Figures 4-6. Higher magnification examination revealed occasional amorphous contaminants embedded with aggregates of microorganisms were also found (as shown in the SEM photomicrographs presented in Figures 4C, 5C & 6C).

SEM Photomicrographs of Media Layer #1

- 4A. Used filter media layer #1

4C. Used filter media layer #1 Note microorganisms embedded in amorphous material.

4B. Unused filter media layer #1

4D. Unused filter media layer #1

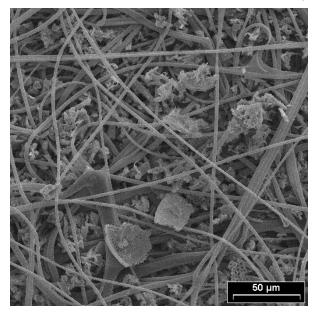
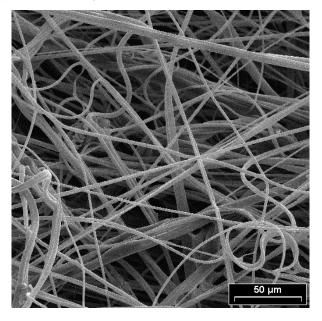
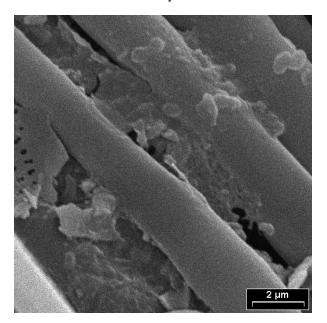
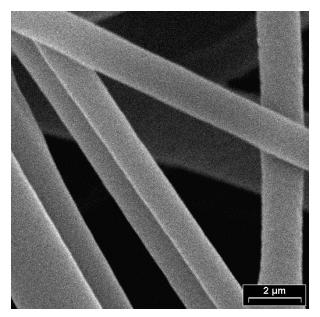
Figure 5.

SEM Photomicrographs of Media Layer #4

5A. Used filter media layer #4

5B. Unused filter media layer #4

5C. Used filter media layer #4

5D. Unused filter media layer #4

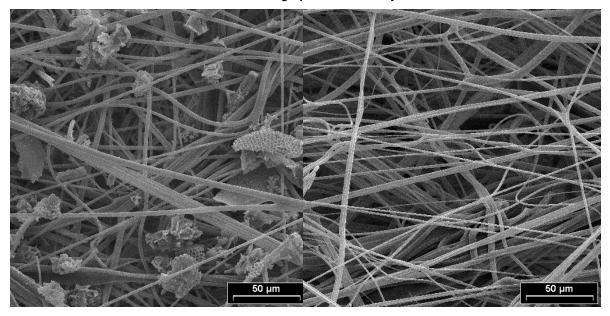
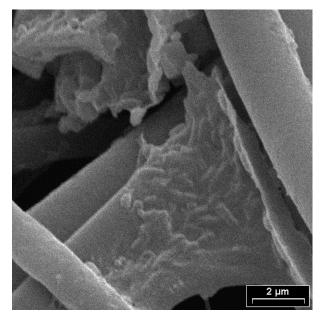
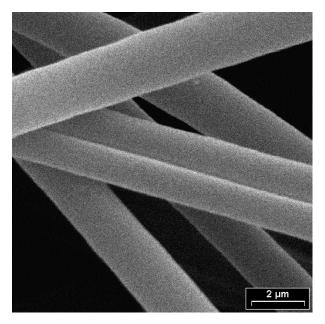
Figure 6.

SEM Photomicrographs of Media Layer #6

6A. Used filter media layer #6

6C. Used filter media layer #6

6B. Unused filter media layer #6

6D. Unused filter media layer #6

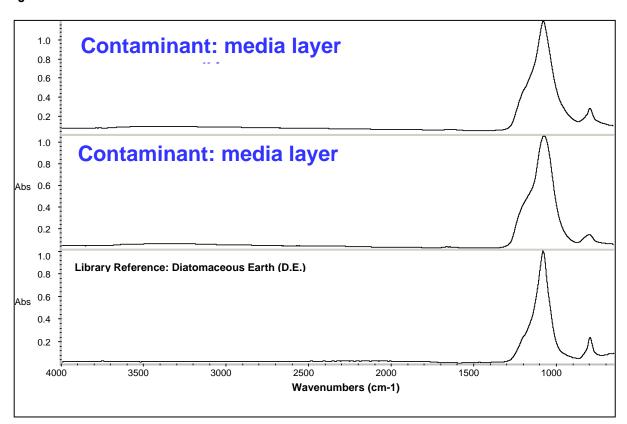
Figure 7.

The beige powdery contaminant found on most layers of the Betapure NT-T Series cartridge produced spectra that were consistent with D.E. (as presented in the FTIR spectra shown in Figure 7).

The contaminants found on the media layers are predominantly Diatomaceous Earth (D.E.) as expected for a filter installed as a D.E. trap filter. Occasional amorphous contaminants embedded with aggregates of microorganisms were also found.
